**TAUNTON RIVER BASIN
TAUNTON, MASSACHUSETTS**

**MILL RIVER DAM
MA 00813**

**PHASE I INSPECTION REPORT
NATIONAL DAM INSPECTION PROGRAM**

APRIL 1979

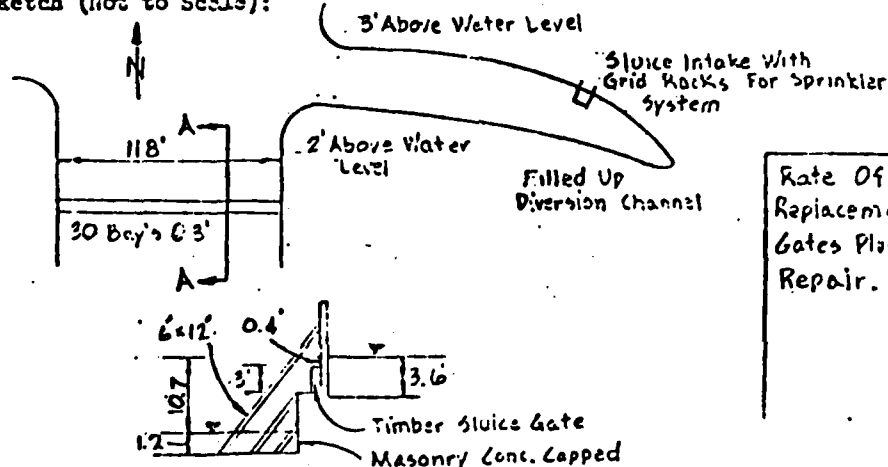
Sketch (Not to Scale):

Buttress dam with 30 manual sluice gates inclusive of one flood gate which reportedly can drain the reservoir in one day, if flow is shut off at the Morays Bridge Dam.

Remarks and Recommendations: Should be examined structurally and hydraulically. Cylinders appear okay, but timber supporting lower portion of dam could not be appraised. It is reported to be in good condition. Overflow capacity may be adequate but should be checked since not more than 2 foot freeboard is available. Recommend opening sluice gates to lower pond level and reduce pressure on dam. Flooding of 1 foot in cellar during 1955 flood. The Whittenton Mfg. Co. owns all water rights above this dam.

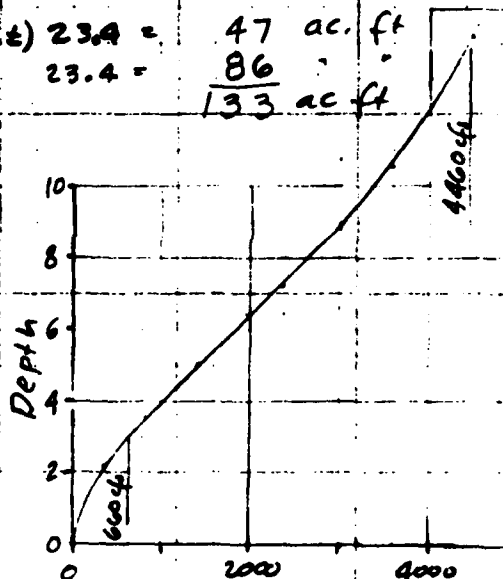
Failure under above test conditions raises depth at bridge from $\pm 3'$ to $\pm 14'$, with a minor flow over Whittenton St. 14 ft depth @ bridge equals elev. ± 60 , which is only one foot below the assumed level in the pond. The street embankment would act as a secondary dam, limiting discharge downstream.
